Roofing No. 3017

Subject: Comparing Polyiso and Molded Polystyrene from the past to today.

Date: August 2016 (Revised January 2019)

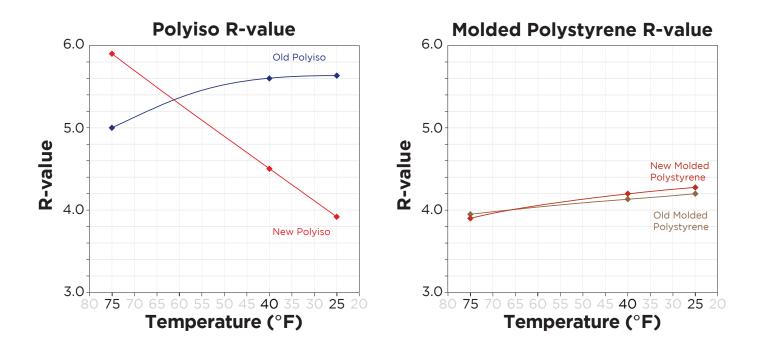
A plot of the R-value for the 17 year old polyiso and new polyiso demonstrates the dramatic change in polyiso insulation in recent years. "New" polyiso loses significant R-value at cold temperatures. In comparison, the R-value for 17 year old molded polystyrene and new molded polystyrene are similar. This demonstrates that molded polystyrene can be trusted to have stable R-value performance.

A school building located in Minnesota was undergoing a roofing system replacement in 2016 and it provided a perfect opportunity to evaluate the performance of the existing roof insulations. The school was originally built in 1999 and consisted of a combination of polyio and molded polystyrene roof insulation. Samples of both products were removed from the roof and evaluated for R-value at various temperatures (See figures on page 3).

It is very important to understand that the latest generation of polyiso insulations and molded polystyrene have very similar R-values when used at cold temperatures. This has dramatic implications when selecting your insulation product and its thickness for use in cold weather and cold storage applications.
