## Perform Guard No. 6006

**Subject:** SIPs

# Boron-treated expanded polystyrene insulation resists native subterranean termite damage after 3-year field exposure

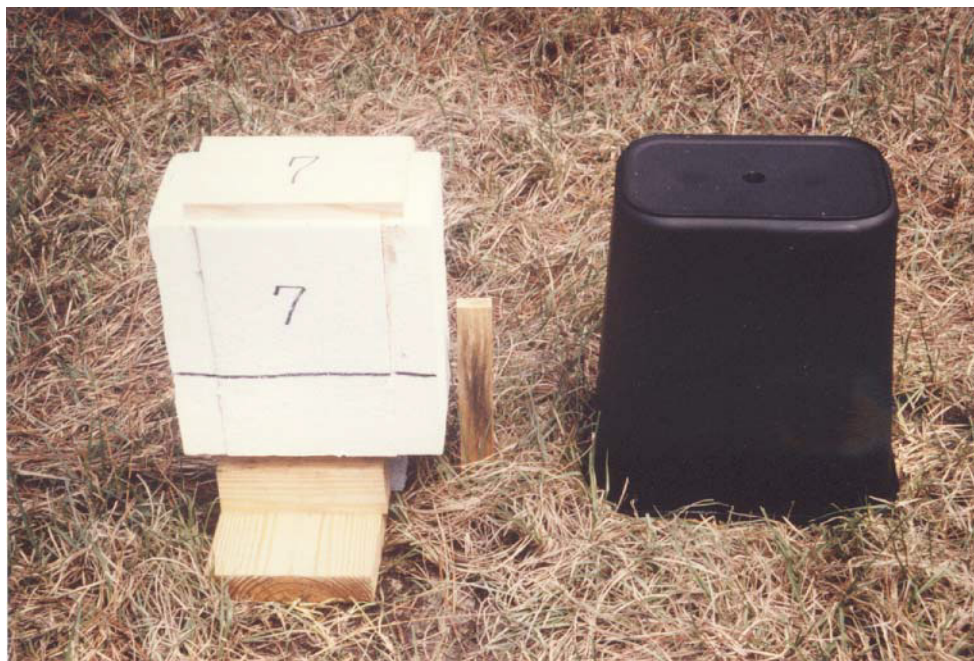
**TEST FIXTURE - Prior to installation showing underground baitwood base to attract termites to site. Canister cover to protect termite activity.**

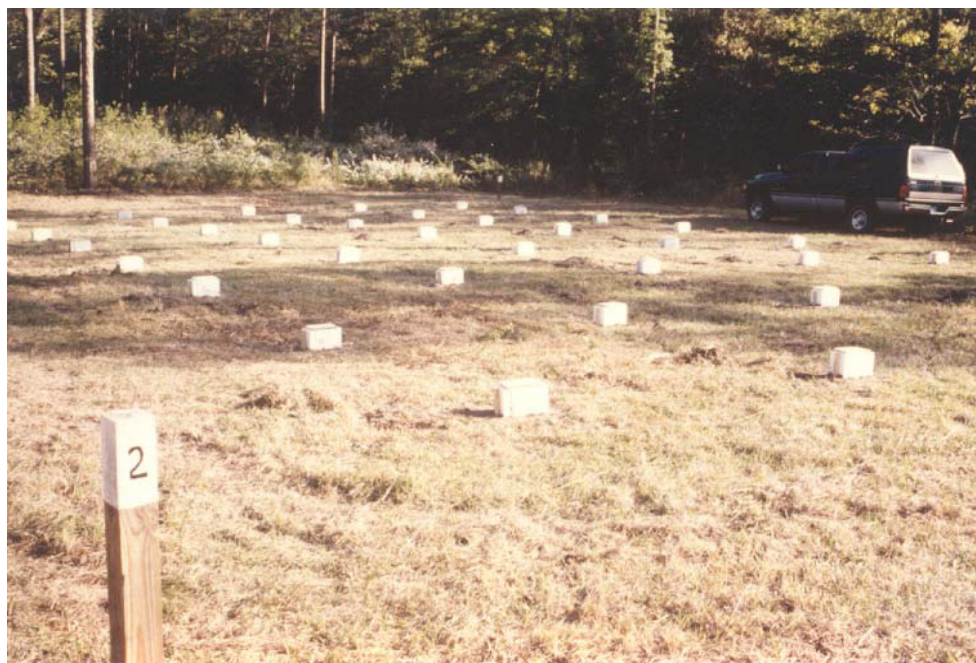
**Field installation of test textures - Stone County, Mississippi.**

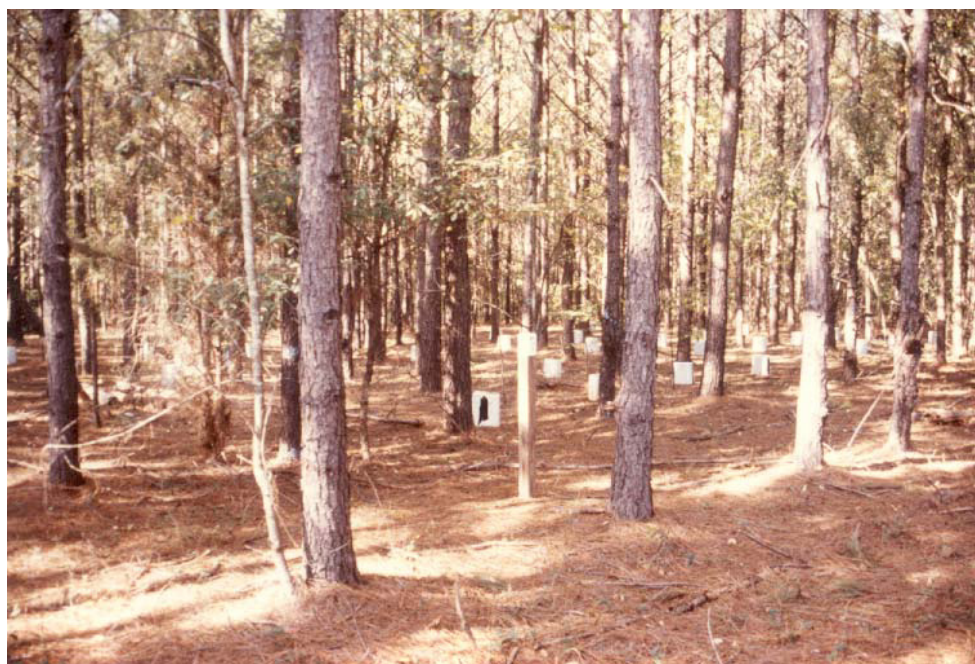
**Field installation of test textures - Griffin, Georgia.**

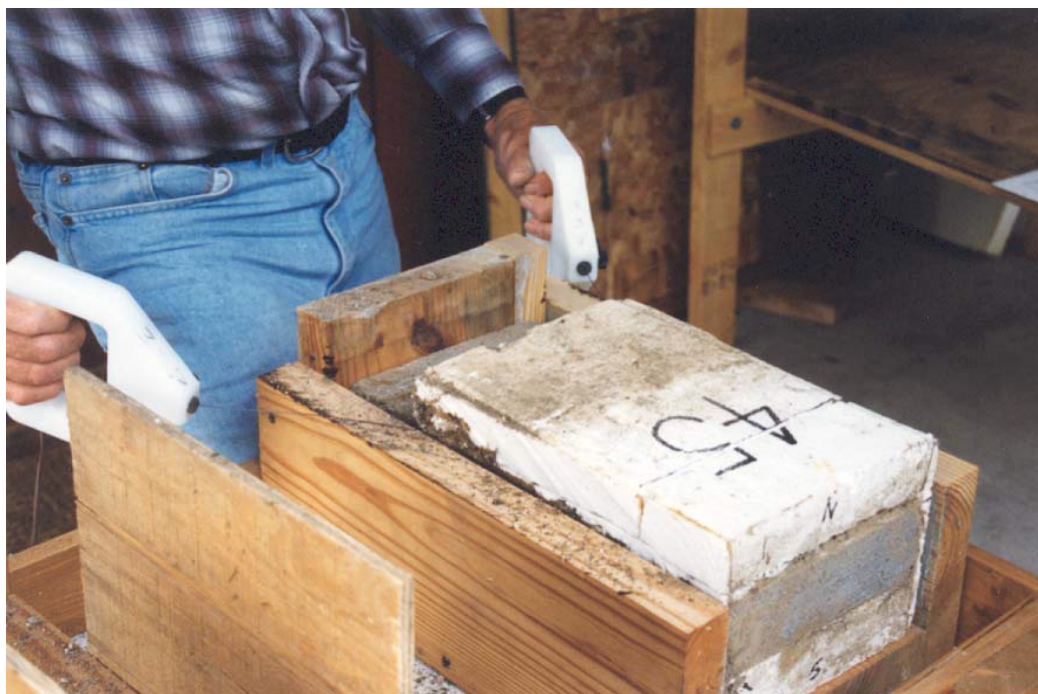
**#45 TEST FIXTURE - Examination of of non-treated EPS after 3 years exposure.  
Highland Site, Mississippi.**

The performance of the PowerFoam with Perform Guard sample is quite dramatic when compared to untreated insulation. Untreated insulations shows very obvious damage resulting from extensive excavation and tunneling. In contrast, PowerFoam with Perform Guard shows very little damage.

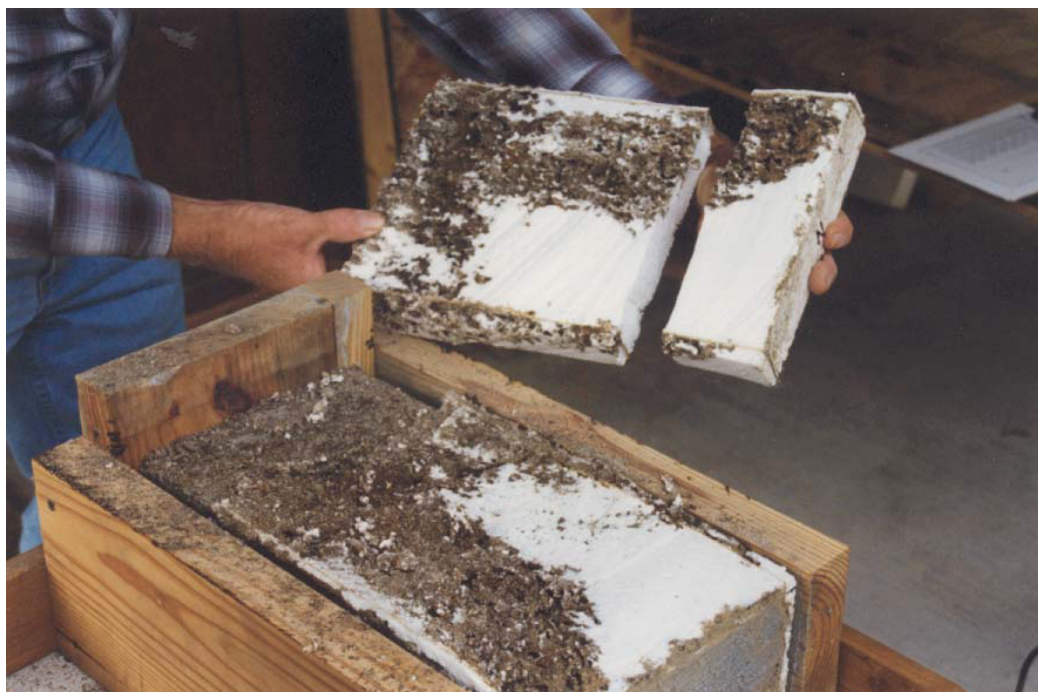
**#45 TEST FIXTURE - cut open to reveal extensive termite damage.**

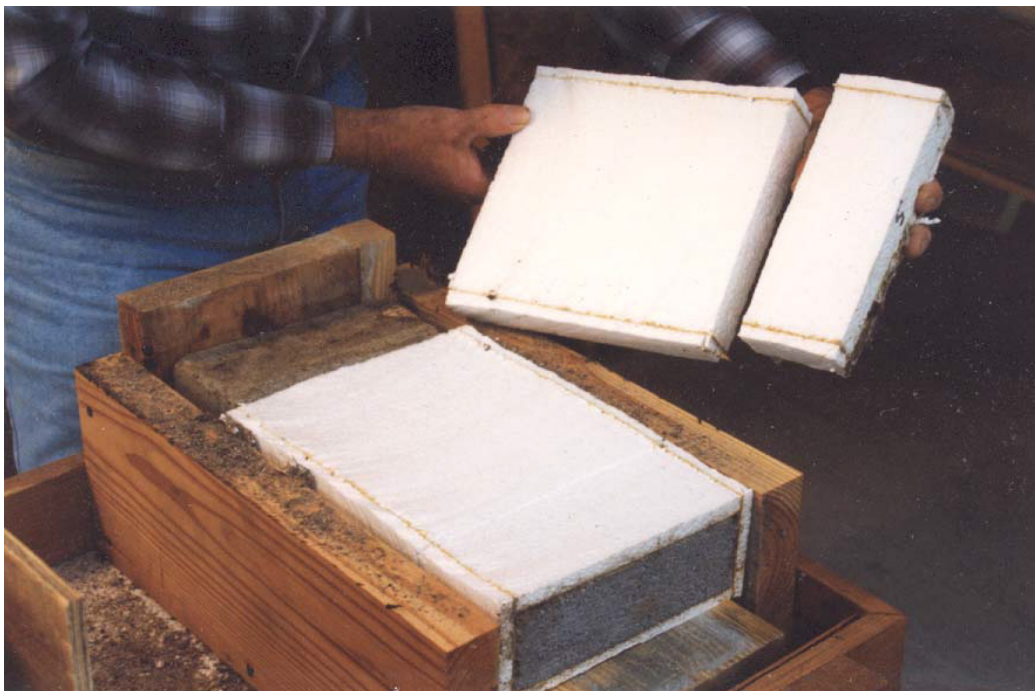
**#64 TEST FIXTURE - Close-up shows no termite damage.**

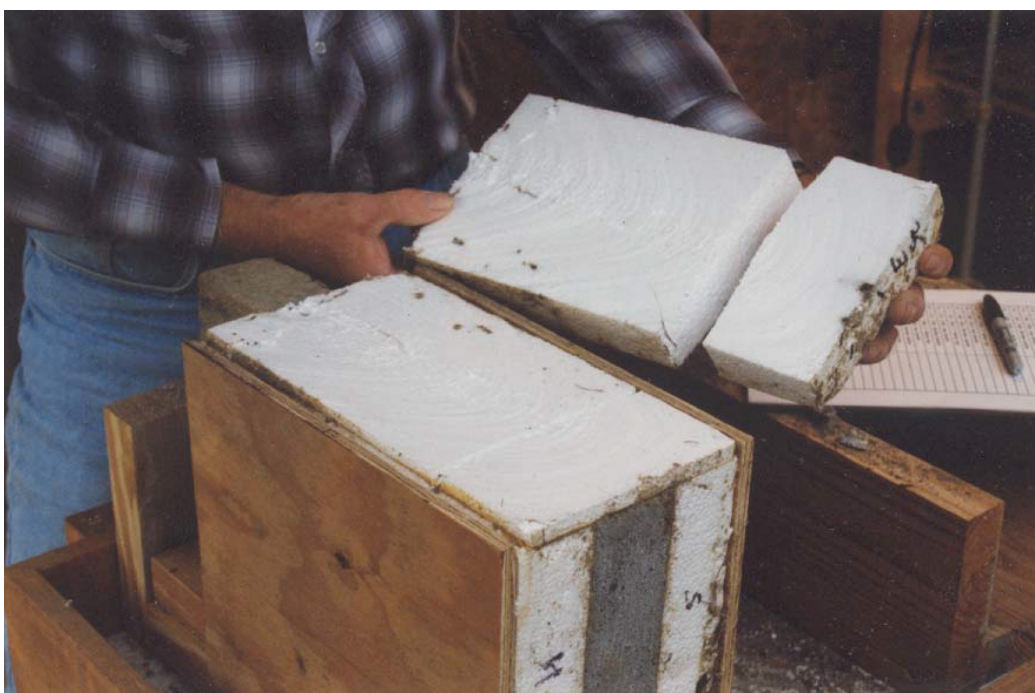
**#64 TEST FIXTURE - Close-up shows slight termite damage.**

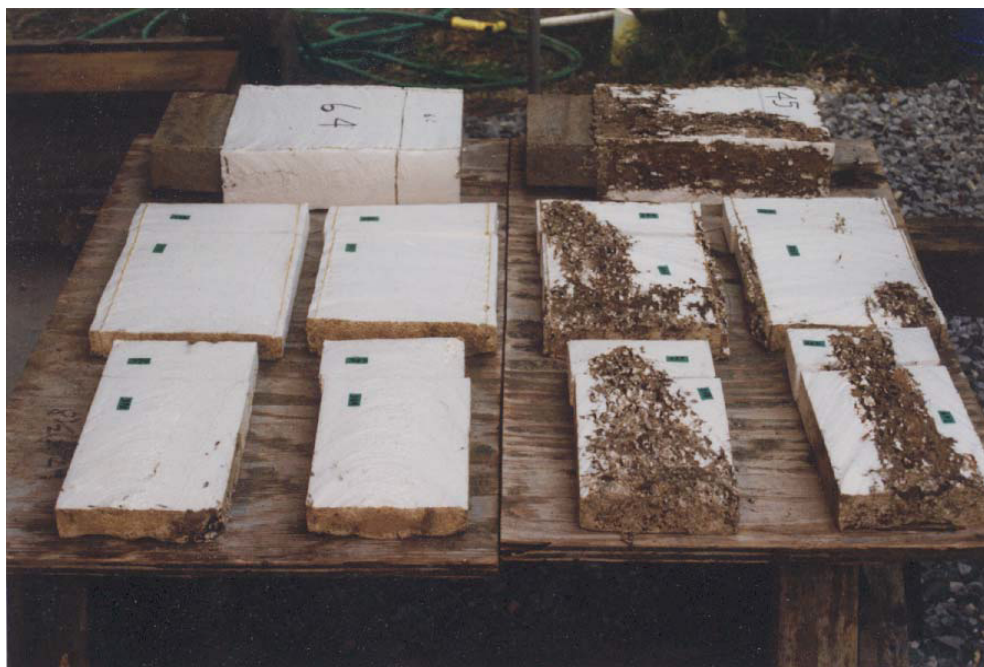
**#64 TEST FIXTURE -  
PowerFoam with Perform  
Guard and R-Control  
Do-All-Ply.**

**#45 Test Fixture -  
Non-Treated MPS and standard  
construction adhesives.**

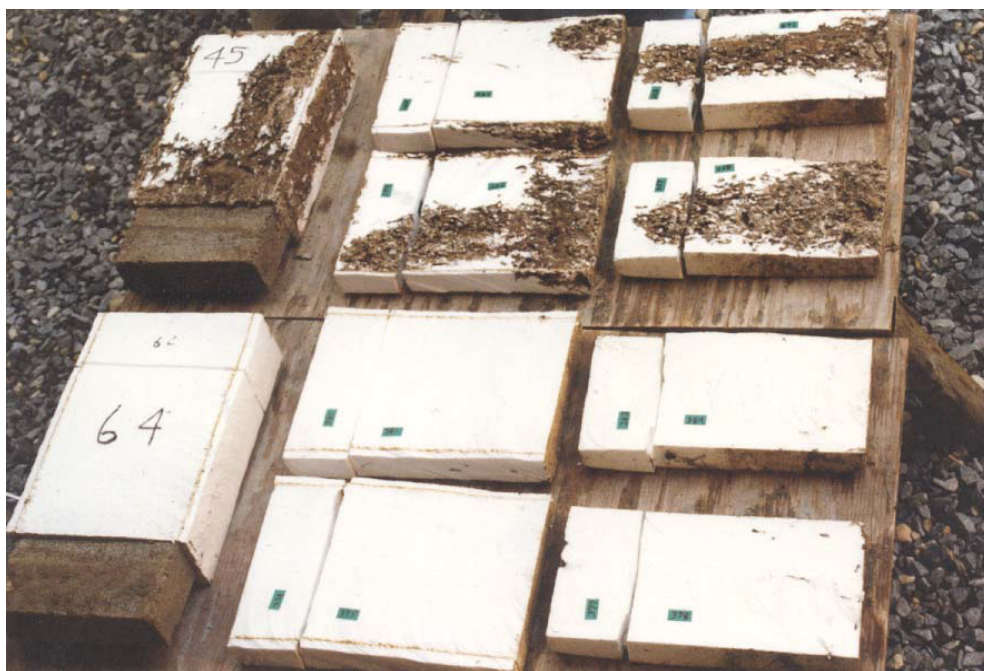
**#64 and #45 TEST FIXTURES - Close-up comparison.**

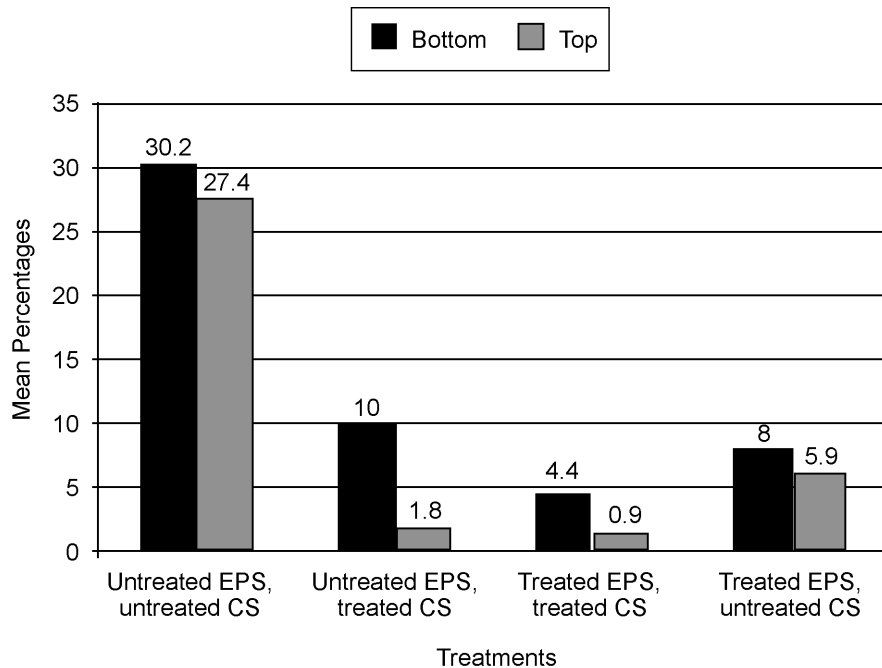
Figure 3. — Mean percentages of termite-damaged insulation per treatment for bottom and top samples of units in all plots after 3 years of field exposure ( $n = 60$ ). Means shown are after subtraction of an error factor associated with image analyses of 2.7 for bottom and 3.4 for top samples:  $n$  for error factors = 28 and 145, respectively.

Analysis was conducted to compare the damage to the top part of samples with that in the lower or bottom part of the sample. Damage to the top region would indicate significant tunneling throughout the EPS. Mean percentages of damage for all plots were always higher for bottom samples than top samples for all treatments (Fig. 3). This was true across all plots and in each plot. For untreated EPS and untreated CS, damage was 30.2 percent for top samples and 27.4 percent for bottom samples. However, damage was 0.9 percent for top samples and 4.4 percent for bottom samples from units with treated EPS and treated CS, indicating that termites were only making exploratory attacks at the bottom of treated EPS pieces adjacent to the large underground baitwood. When

only EPS or CS was treated, damage to top samples was from 8.0 to 10.0 percent and damage to bottom samples was from 1.8 to 5.9 percent (Fig. 3).
